6.3.1 1950-1969

8.3.1.1 Building 816

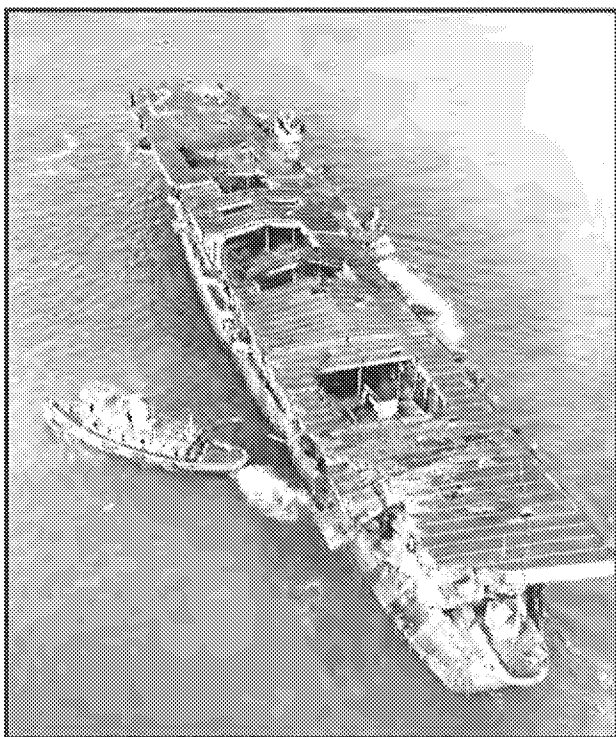
Ex-INDEPENDENCE Prior to Being Sunk in January 1951
(San Francisco Maritime National Historical Park,
National Park Service)

Since its return from OPERATION CROSSROADS, the carrier ex-INDEPENDENCE was retained for use by the RADLAB and subsequently by NRDL for experimentation, testing of decontamination methods, storage of radioactive wastes, and as a dockside laboratory (HRA-361, p 1; HRA-1639, p 2; HRA-1702; HRA-1708). In 1950, ex-INDEPENDENCE was docked at Berths 16 and 17 at the Regunning Pier (Gun Mole), where NRDL had a field laboratory that managed work on the carrier. This field laboratory eventually included a converted barge (YFNX-16), a decontamination pad, and personnel clothing change and decontamination facilities (HRA-253; HRA-396). Ex-INDEPENDENCE, loaded with radioactive waste from NRDL and other generators, was towed to sea and sunk in January 1951 (HRA-1424; HRA-1739; HRA-1910; HRA-1925; HRA-2721).

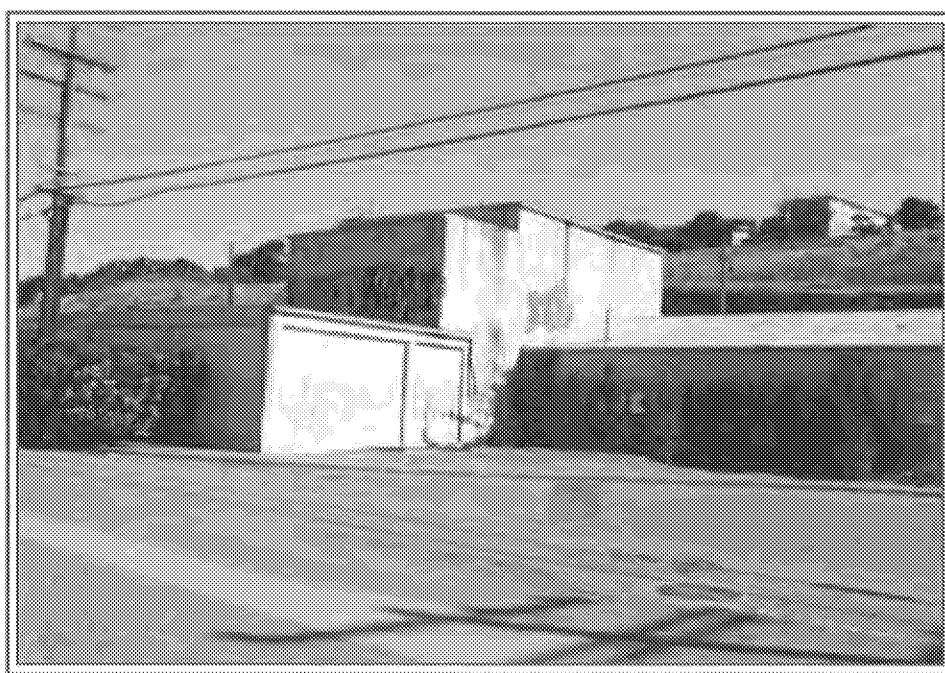
Site Description: Originally was a windowless, two-story concrete structure completed in December 1953 (HRA-1051, p 1 of 3). Building wing to the right in the photograph was added from 1956 to 1957 and houses the neutron pit. The upper floor housed the Van de Graaff accelerator and its associated mechanical/electrical equipment. The ground floor was devoted to a laboratory, machine shop, and control room (HRA-2113, p 7). One of the unique features of the building is a 4-foot-thick, 30-ton door at the south end. A steel addition was constructed to perform low intensity proton experiments (HRA-177). Figure 8.3.1.1 provides a site plan, and Figure 8.3.1.1FP provides a floor plan of the building in 1954.

Former Uses: Two-Megaelectron volt (MeV) Van de Graaff Neutron Generator, chemical-biological laboratory, offices, and machine shop (HRA-2113, p 7).

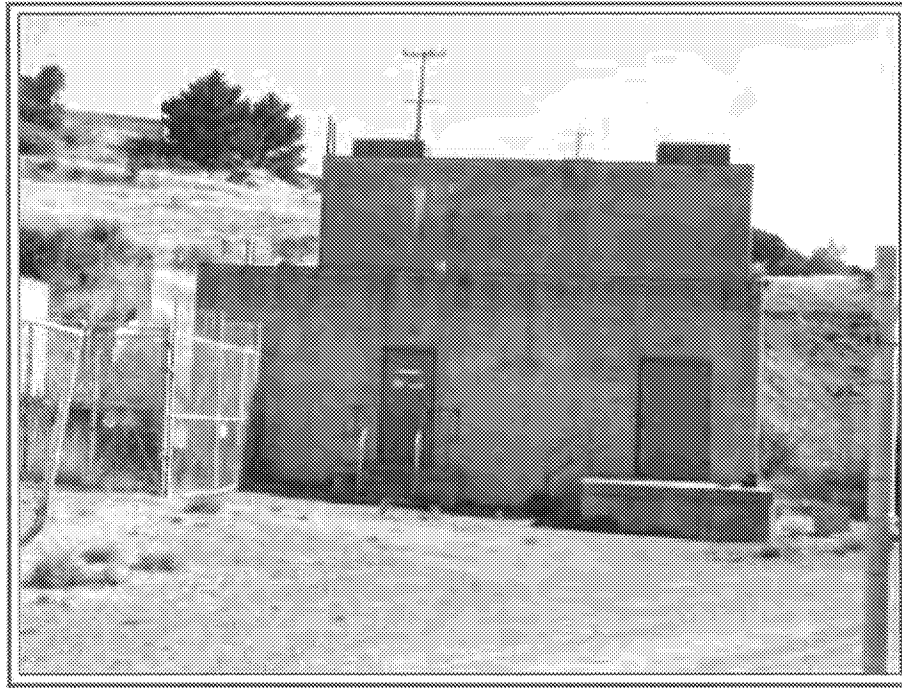
Site Description: A two-story concrete laboratory building, used for the study of animal irradiation through electro-magnetic means (non-radionuclide generated). An electrical power substation is located outside of the western side of the building. Figure 8.3.1.2 provides a site plan.

Former Uses: One-MeV X-ray generator (HRA-2772, p 20) and X-ray laboratory.

Recommended Actions: No Further Action; released by RASO and CDHS.

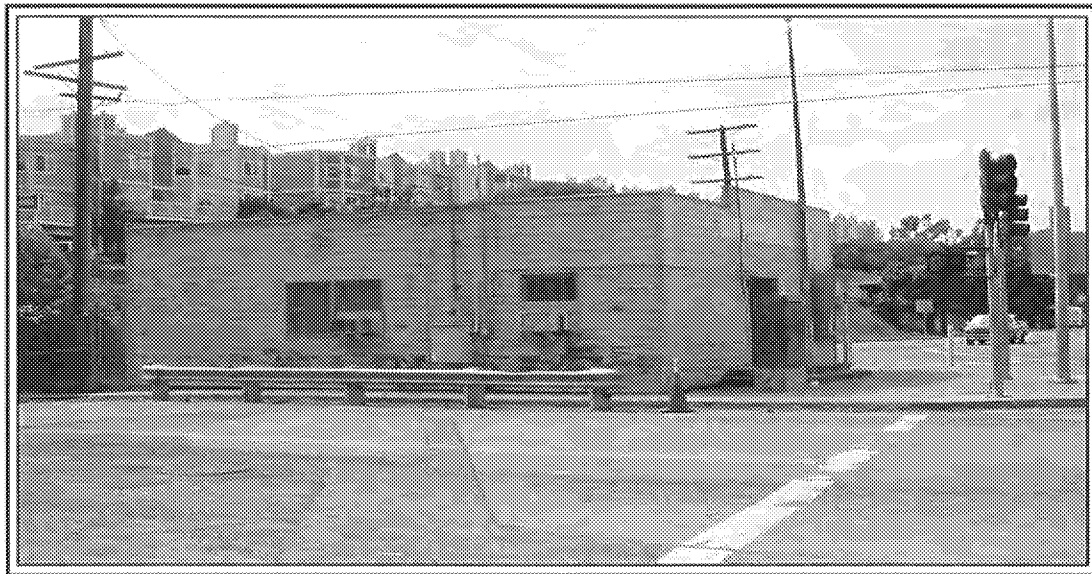
Building Description: The former Building 322 was of WW II era administration building design, built from standardized Bureau of Yards and Docks plans (HRA-1118, p 22). A site plan is provided in Figure 8.3.1.2 above.

Former Uses: NRDL Office (HRA-1327 Encl 1, p 1), NRDL Instruments Branch offices prior to 1959 (HRA-2928, p 5), moved to Parcel A for use as the North Gate Pass Office in 1959 following clearance surveys by NRDL (HRA-333, p 16; HRA-4705). No further NRDL use while located in Parcel A. Information on the former site in Parcel D can be found in Section 8.3.4.5.

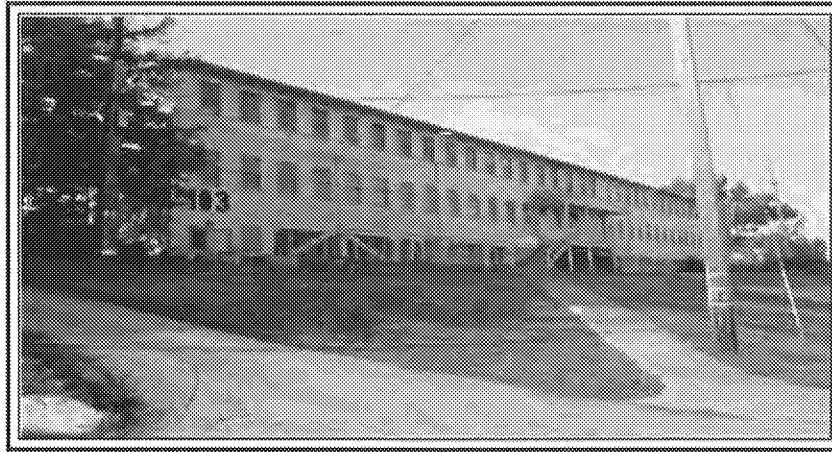
Site Description: Built as a standard WW II wooden barracks, Building 103 is a long, narrow rectangular building topped by a shallow gabled roof with narrow eaves. It sits alongside a pair of similar buildings at the base of the hill (HRA-1118, p 58). A site plan is provided in Figure 8.3.2.1.

Former Uses: Submarine barracks, 1951 (HRA-2963); decontamination center for OPERATION CROSSROADS personnel (HRA-1483).

Recommended Actions: Review Final Status Survey Report.

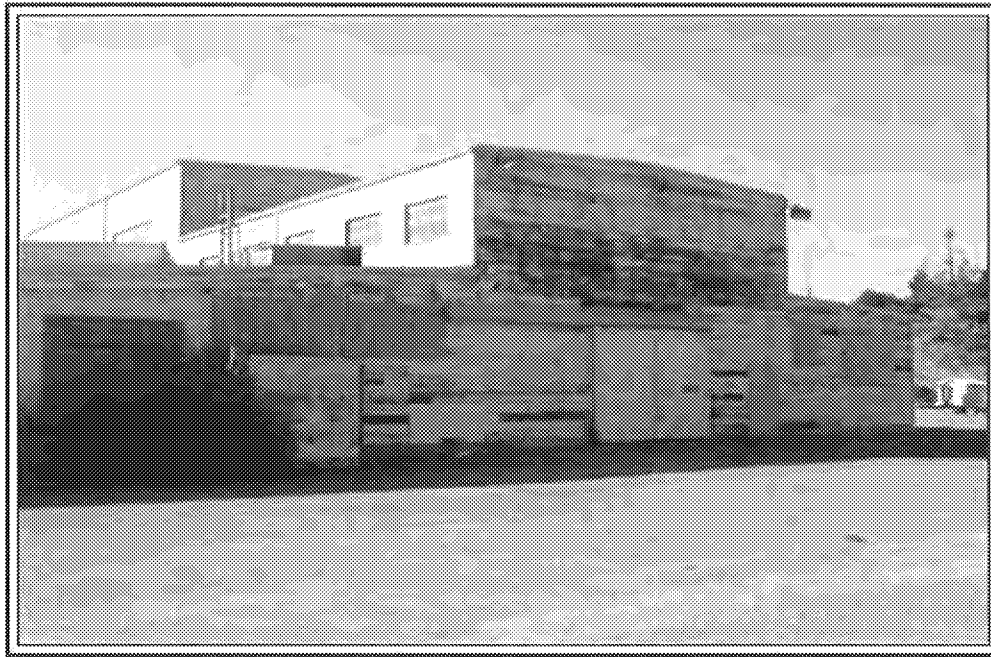
Site Description: Building 113 is a rambling three-story wood-framed shop located in the ex-submarine repair area. It is sided in horizontal boards and has a shallow gabled roof. The building has a central three-story element, a T-shaped two-story element, and a rectangular first story. A site plan is provided in Figure 8.3.2.2, and a floor plan is provided in Figure 8.3.2.2FP.

Former Uses: Tug maintenance, salvage diver facility, torpedo storage and overhaul (1951-1964), and sample storage from atomic weapons tests (HRA-2705 Encl A).

Recommended Action: Review Final Status Survey Report.

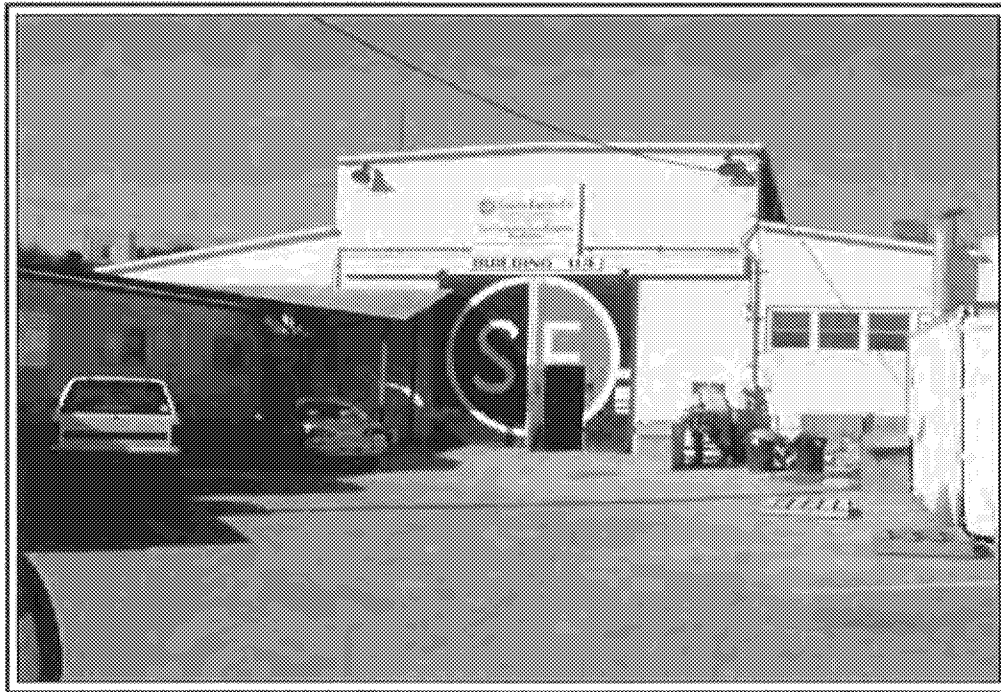
Site Description: Building 113A is a 25-by-25-foot concrete storage vault enclosed by a corrugated, metal-sided, shallow gabled roofed structure that is immediately adjacent to Building 113 (HRA-2798). The building is currently labeled as Building 114, although this is historically incorrect. Figure 8.3.2.2 above provides a site plan of Building 113A, and a floor plan is provided in Figure 8.3.2.3FP.

Former Uses: Torpedo storage building, Non-Destructive Test Facility (Radiography) (HRA-1472 Supplement 1), Machine and Maintenance Shop, Shipyard Analytical Laboratory, Radioactive Material Storage Building, Radiographer's Vault, and radioactive waste storage facility. The building was also used to store sheet lead removed from Building 364 (HRA-600, p 2).

Recommended Action: Review Final Status Survey Report.

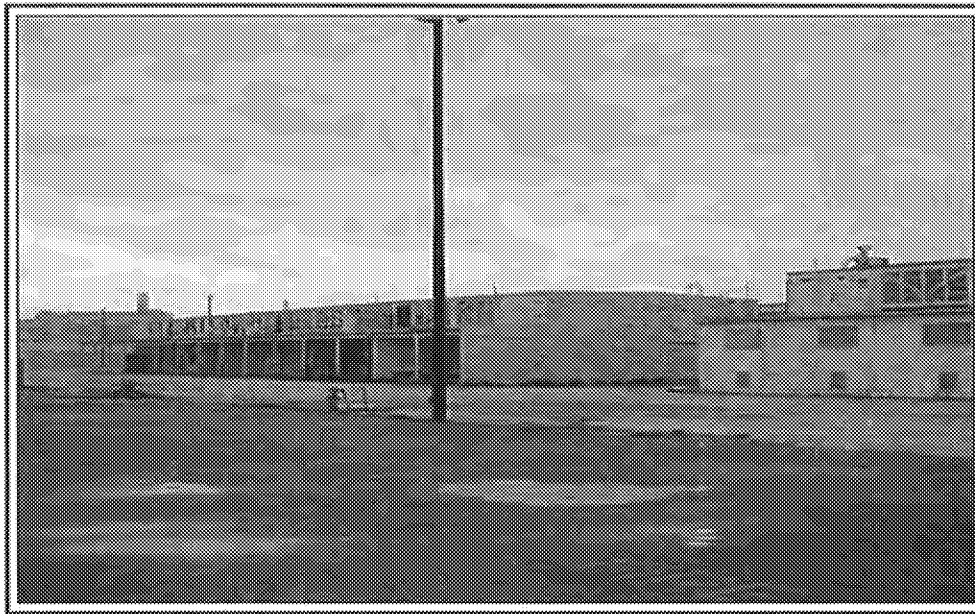
Site Description: Building 130 is a wood-framed shop building located in the former submarine repair area. Built in 1944, the building differs from other shops in that it includes open sheds on both sides and an almost flat, shallow gabled roof. The building also includes wooden sliding industrial doors at either end. A site plan of Building 130 is provided in Figure 8.3.2.5.

Former Uses: Occupied by Protective Finishes Company (1994), PRC used the building as a LLRW storage area (Ra-226 and IDW in 1994) (HRA-1118, p 58), Shop Service (1968 to 1973), pipe fitter shop, general shops, ship repair shop, machine shop, and metal working shop.

Recommended Actions: Review Final Status Survey Report.

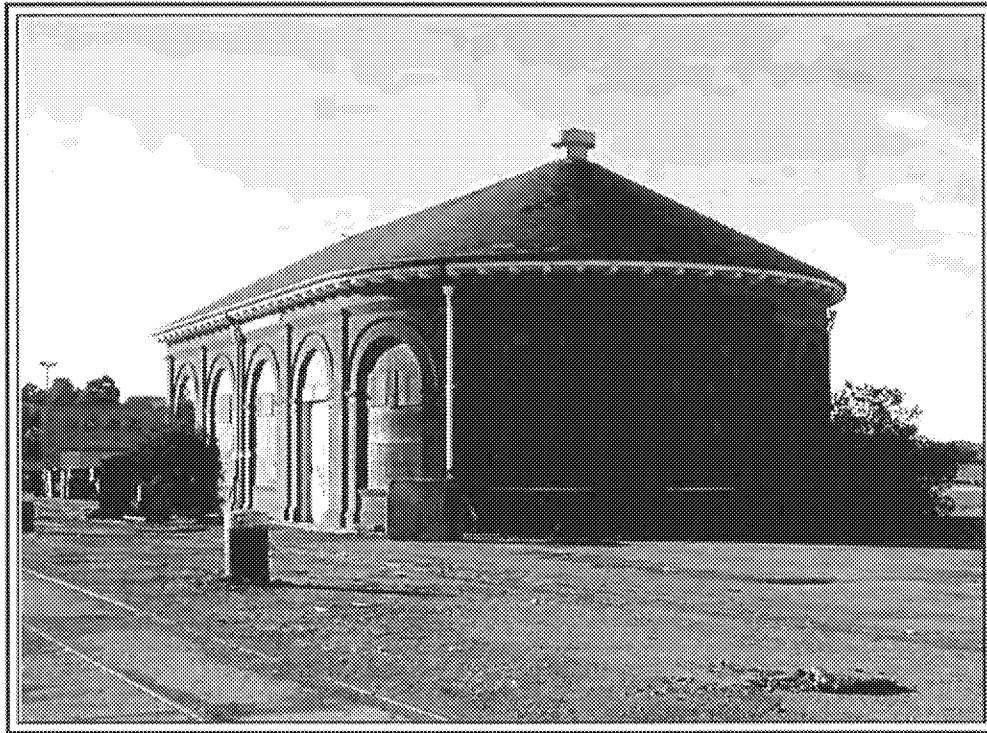
Site Description: Building A is a one-story brick building shaped as a rectangle with a rounded eastern end resembling an apse. The building measures about 96 by 56 feet and is located north of Drydock 3, about midway along the drydock (HRA-1117, p 133). A channel for water from Drydock 3 passes in a straight line north from the drydock through the pumphouse to the Bay (HRA-4689). A site plan of Building 140 is provided in Figure 8.3.2.6.

Former Uses: Drydock Pumphouse No. 3 and discharge channel (HRA-1117, p 133).

Recommended Actions: Scoping Survey of structure, equipment, and discharge channel. Characterization and remediation if contamination is found. Final Status Survey.

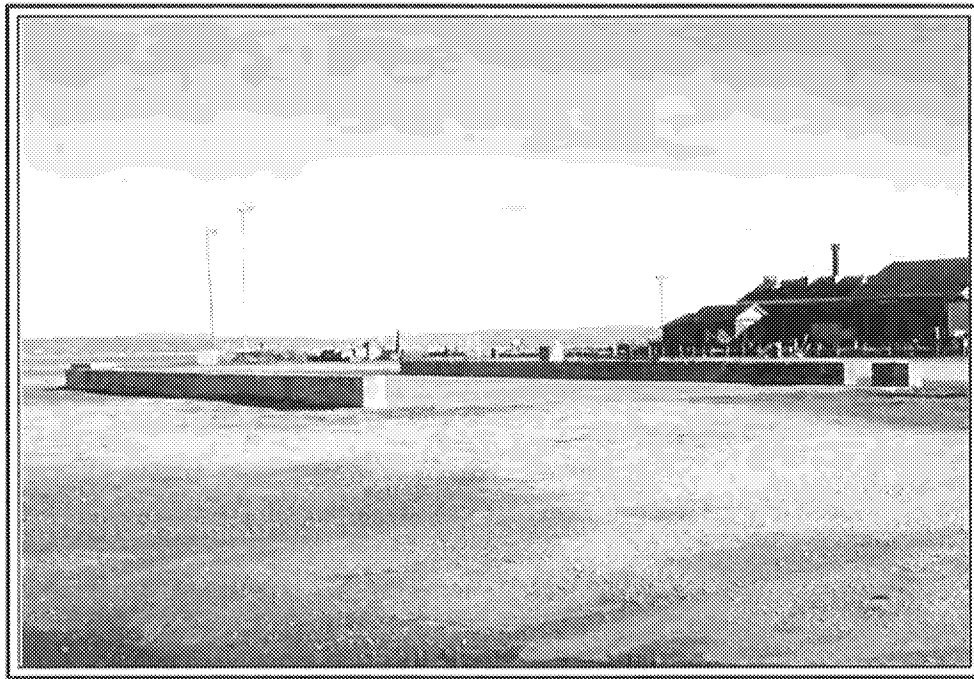
Site Description: Building 142 is a partially demolished concrete air raid shelter thought to be similar to Building 224. It is unclear from historical references whether this structure was above or below ground (HRA-2963). A site plan is provided in Figure 8.3.2.6 above.

Former Uses: Air Raid Shelter A (HRA-2963), weapons test high-level sample storage, and low background sample counting room (HRA-405).

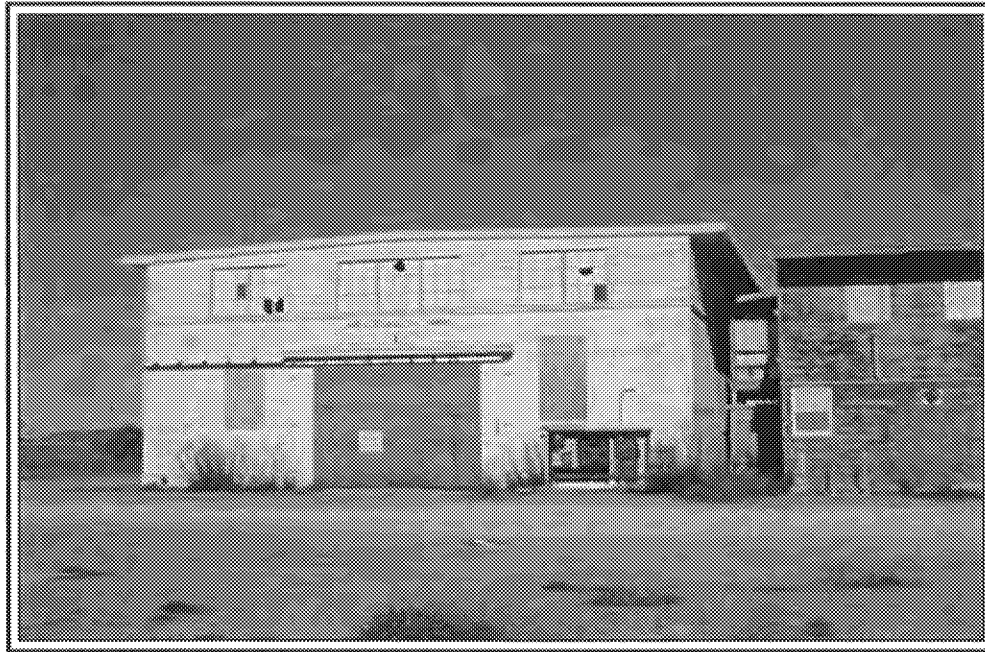
Site Description: Building 146 is a wood-framed, shallow gabled roofed shop with windows throughout that was built in 1945. The building is two storied, sided in stucco on the first story and asbestos shingles on the second. Large sliding wooden doors provide access to the building. A site plan is provided in Figure 8.3.2.8, and a floor plan is provided in Figure 8.3.2.8FP.

Recommended Actions: Characterization Survey. Remediation if contamination is found. Final Status Survey.

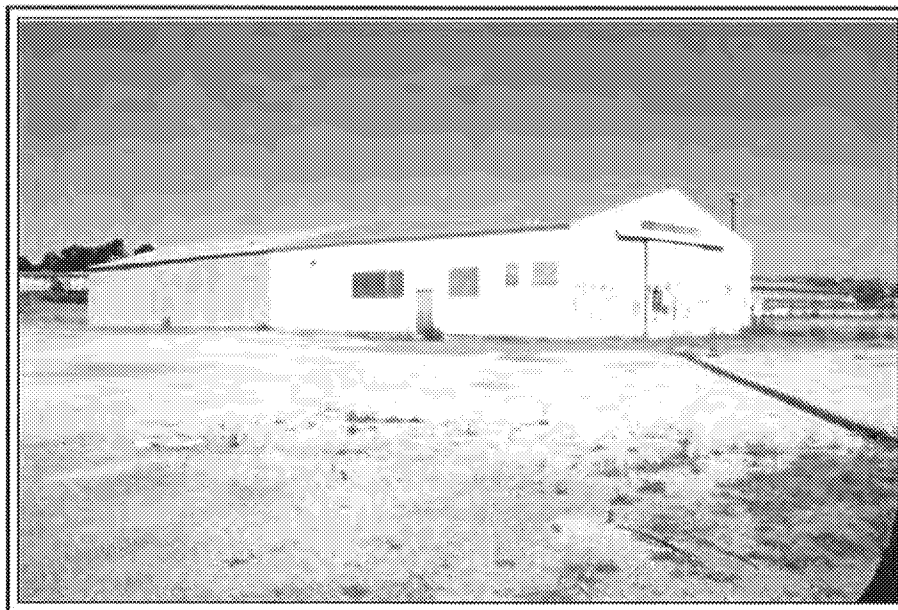
Site Description: Building 157 is a corrugated metal, wood-framed structure approximately 40 feet by 140 feet in size. Specific historical descriptions of the building were not found. A site plan is provided in Figure 8.3.2.9.

Recommended Actions: Scoping Survey. Characterization and remediation if contamination is found. Final Status Survey.

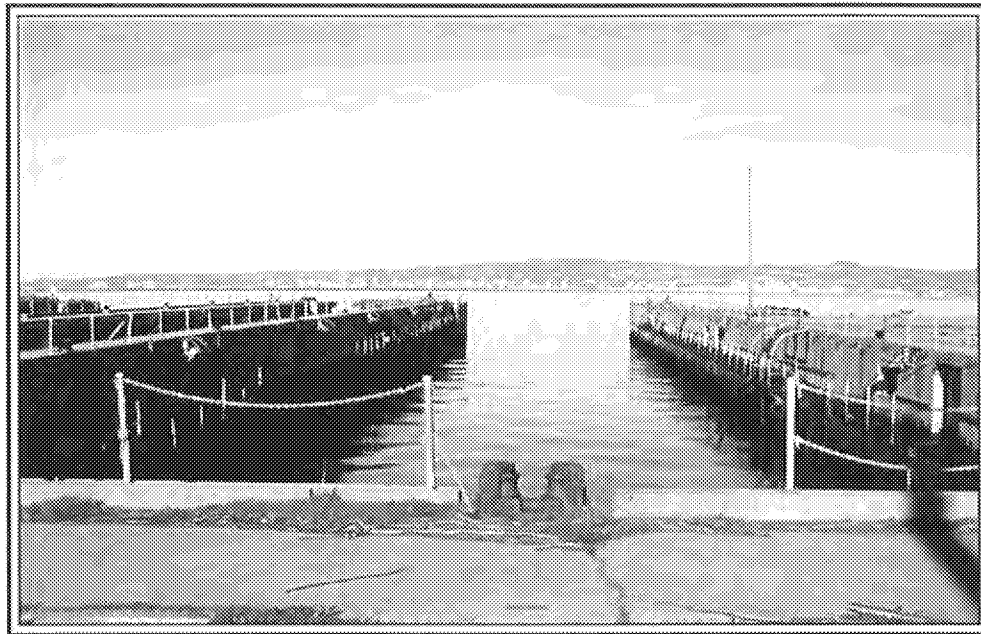
Site Description: Built in 1944, the chief function of Drydock 5 was submarine repair, but it was also capable of housing destroyers and other relatively small vessels. The drydock is 420 feet by 60 feet, with a gate that is hinged at the bottom that flaps down to allow the vessel to enter. The drydock was dewatered by four 20,000-gallons per minute (gpm) pumps. Two pumps were located at each side of the Bay end of the dock (HRA-4683). A drydock site plan is provided in Figure 8.3.2.10.

Recommended Actions: Scoping Survey of structure and pumping equipment.
Characterization and remediation if contamination is found. Final Status Survey.

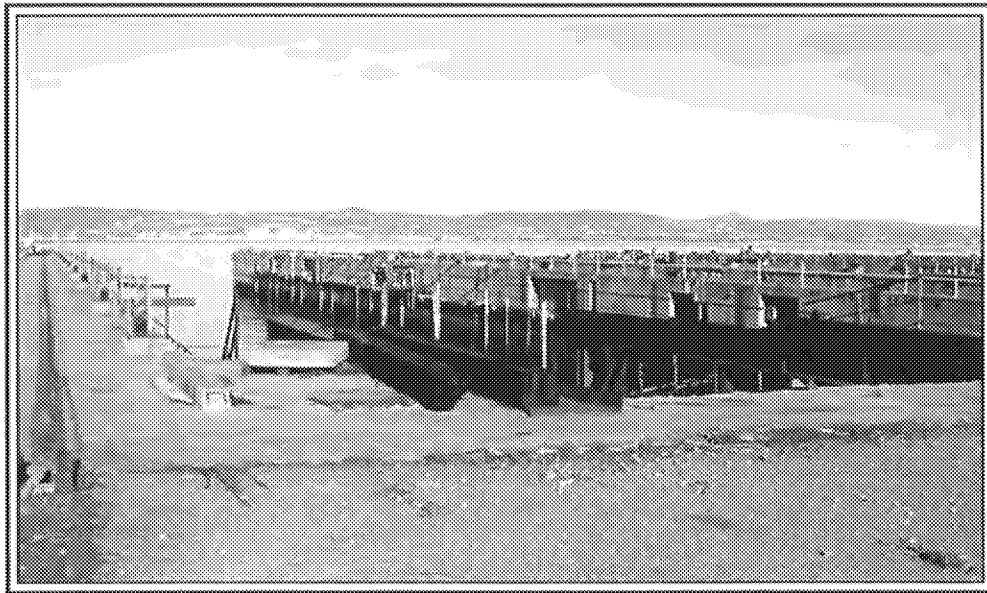
8.3.2.12 Drydock 7

Site Description: Drydock 7 was built in 1944 for submarine repair, but was also capable of housing destroyers and other relatively small vessels. The drydock is 420 feet by 60 feet, with a gate that is hinged at the bottom that flaps down to allow the vessel to enter. The drydock was dewatered by four 20,000-gpm pumps. Two pumps were located at each side of the Bay end of the dock (HRA-4683). A drydock site plan is provided in Figure 8.3.2.10 above.

Former Uses: Possible Decontamination Drydock for OPERATION CROSSROADS and Ship Repair (Submarines).

Recommended Actions: Scoping Survey of structure and pumping equipment.
Characterization and remediation if contamination is found. Final Status Survey.

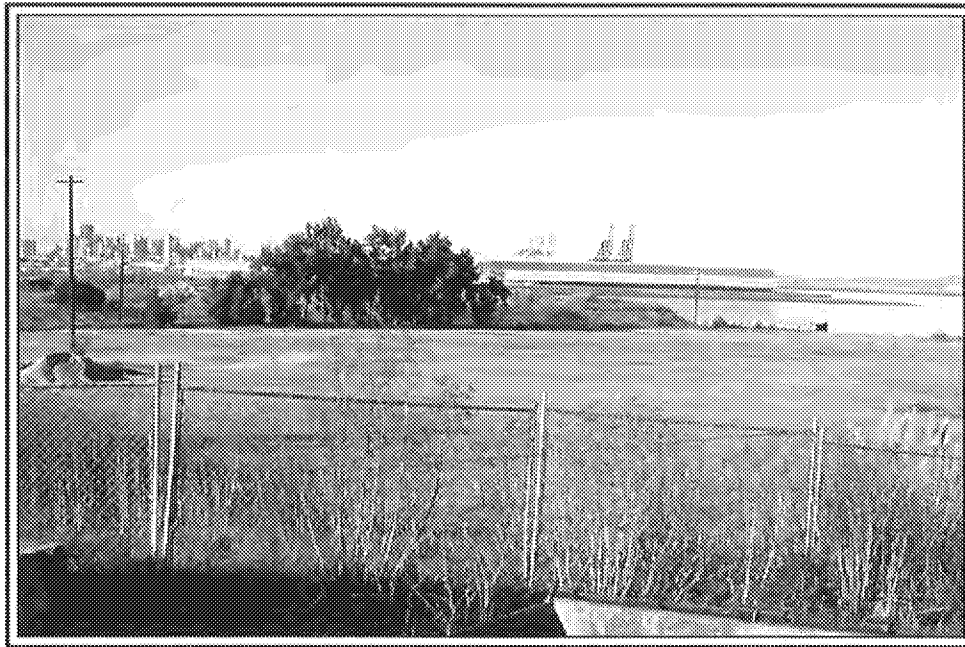
8.3.2.13 IR-07

Site Description: IR-07 is a former disposal area located northeast of Building 916 and on a line 25 feet below Donahue Street. IR-07 is approximately 700 feet by 700 feet in size. A site plan is provided in Figure 8.3.2.13.

Former Uses: Flat land area built by the Navy used to support conventional (non-nuclear) submarine maintenance. Potential disposal of waste from decontamination of ships from OPERATION CROSSROADS.

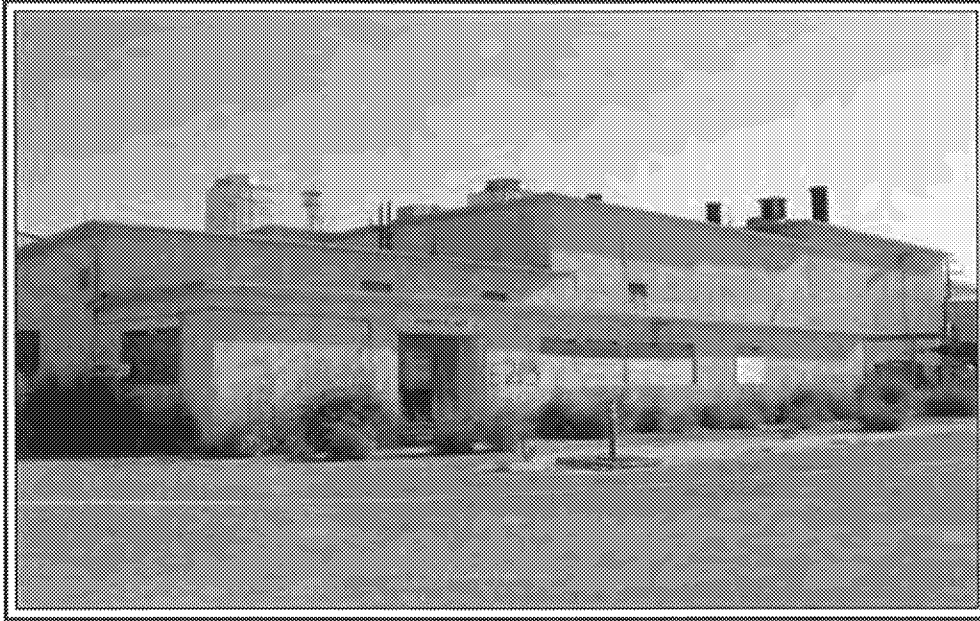
Site Description: Building 203 is a large reinforced concrete building housing a power plant (HRA-2963). Constructed in 1943 and extended in 1945, the building measures 152 feet by 137 feet (HRA-1118, p 58). The building is also referred to as Substation H (HRA-4667). It has a flat reinforced concrete roof with a slight overhang. The building includes a major addition that is sided in corrugated metal, likely the 1945 extension. A building site plan is provided in Figure 8.3.3.1, and a floor plan is provided in Figure 8.3.3.1FP.

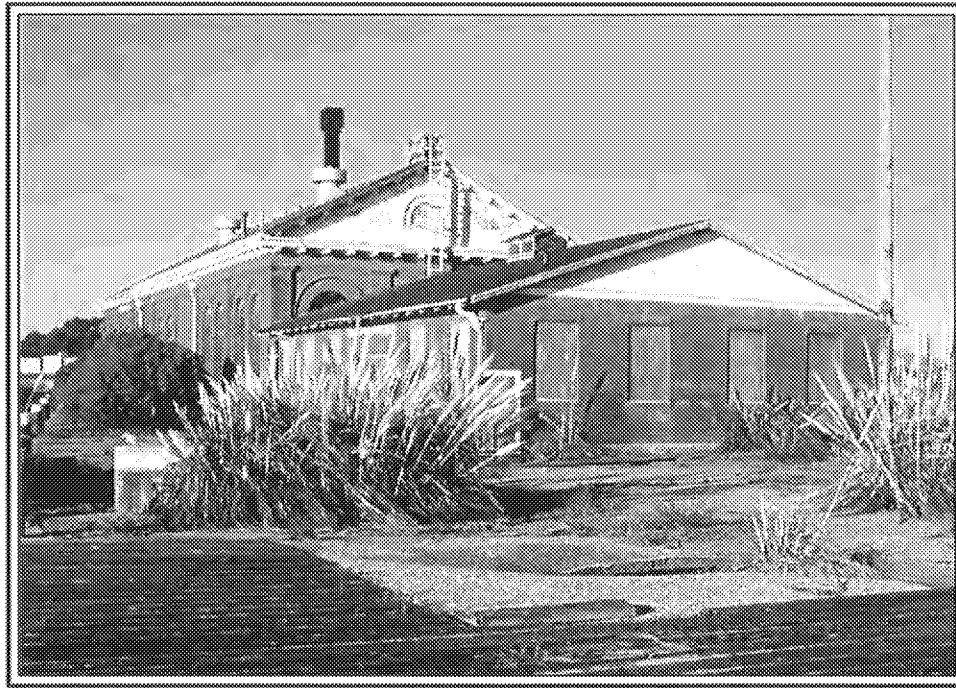
Site Description: Building 205 is a single-story L-shaped brick building, measuring 211 by 61 feet. Two WW II era additions were made to the rear of the original building. The building houses the pumping machinery for Drydock 2 (HRA-1119, p 54; HRA-4667). A discharge tunnel connects the building to the drydock. There is also a channel connecting the building to Drydock 3 (HRA-4686). A site plan is provided in Figure 8.3.3.2.

Former Uses: Pumphouse for Drydock 2.

Recommended Actions: Scoping Survey. Characterization and remediation if contamination is found. Final Status Survey.

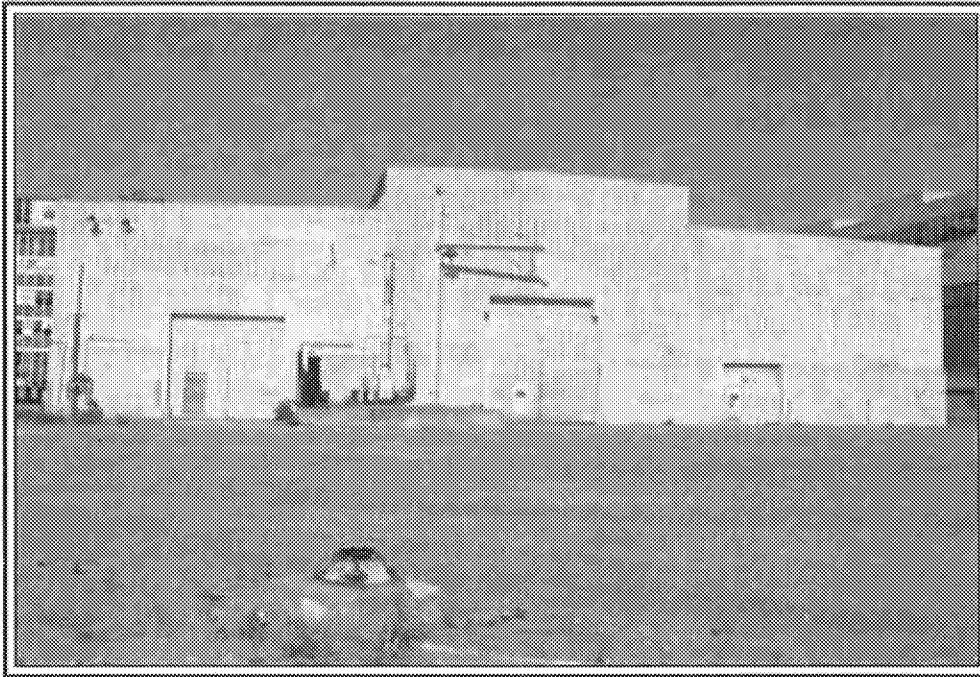
Site Description: Building 211 is a three-story concrete-framed, curtain-walled building that was built in 1942 (HRA-1118, p 92). It is a large warehouse-type building, with a large gantry for craning materials to the upper stories. Building 211 is attached to Building 253 (HRA-1118, p 94). A building site plan is provided in Figure 8.3.3.2 above.

Former Uses: Machinery and electrical test/repair shop (HRA-2963; HRA-4667) and contractor LLRW storage site.

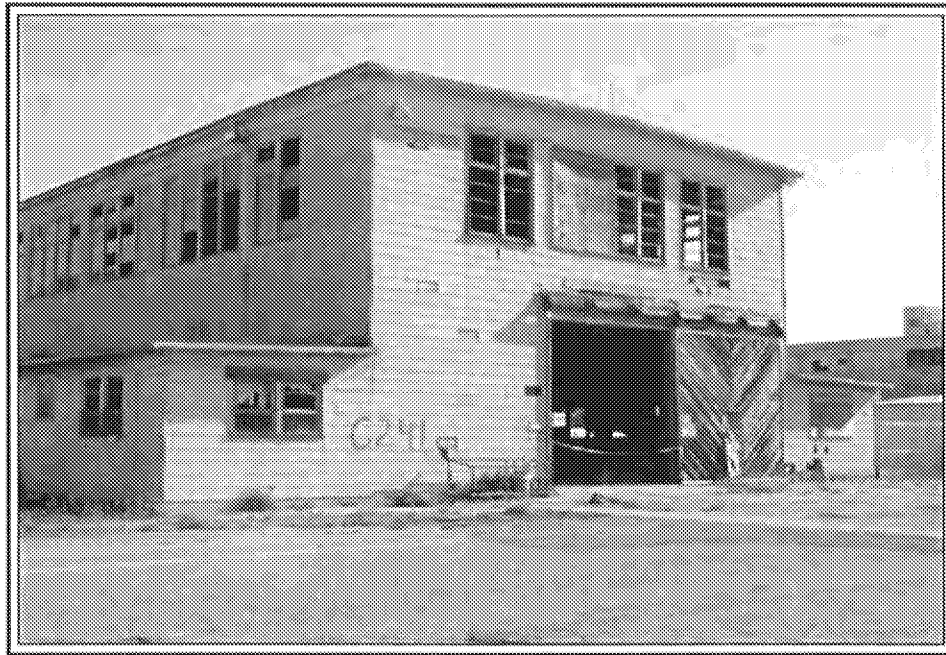
Site Description: Building 241 is a large wood-framed, monitored (lights and ventilation) shop building, including a shallow, almost flat, gabled roof with monitors and shallow shed-roofed forms at either side. A building site plan is provided in Figure 8.3.3.6.

Recommended Actions: Review Final Status Survey Report.

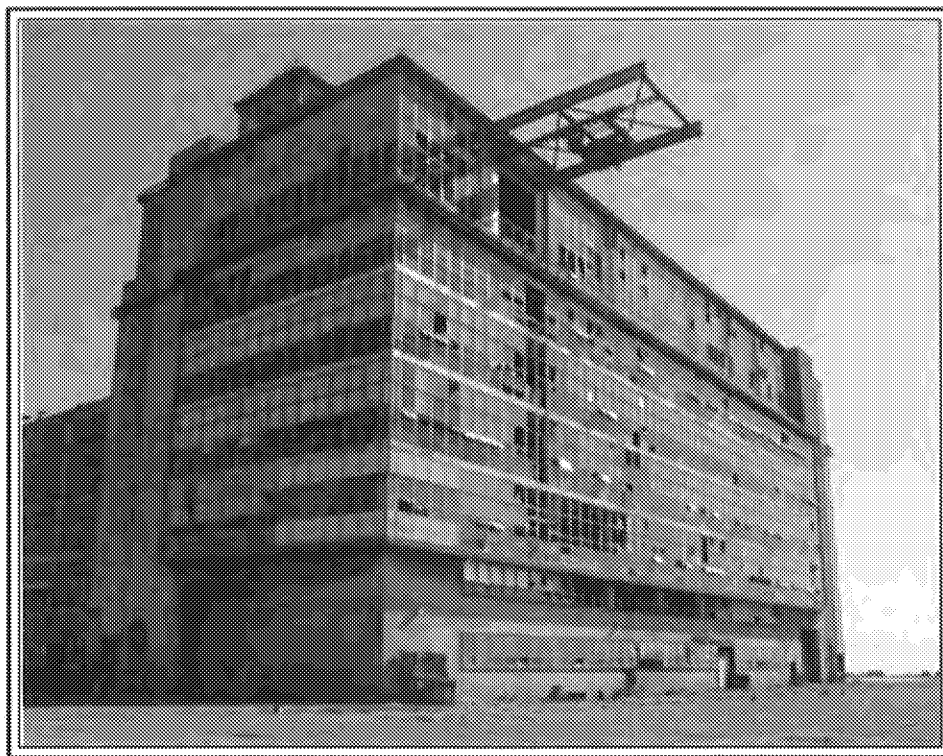
Site Description: Building 253 is a six-story concrete-framed, glass curtain-walled building built between 1944 and 1947. The building has a large gantry for the craning of equipment to the upper stories and a periscope tower extending vertically from the roof. Building 253 is attached to Building 211 (HRA-1118, pp 94-96). The glazing for Building 253 is standard glass. A building site plan is provided in Figure 8.3.3.2 above, and a floor plan (first floor) is provided in Figure 8.3.3.7FP.

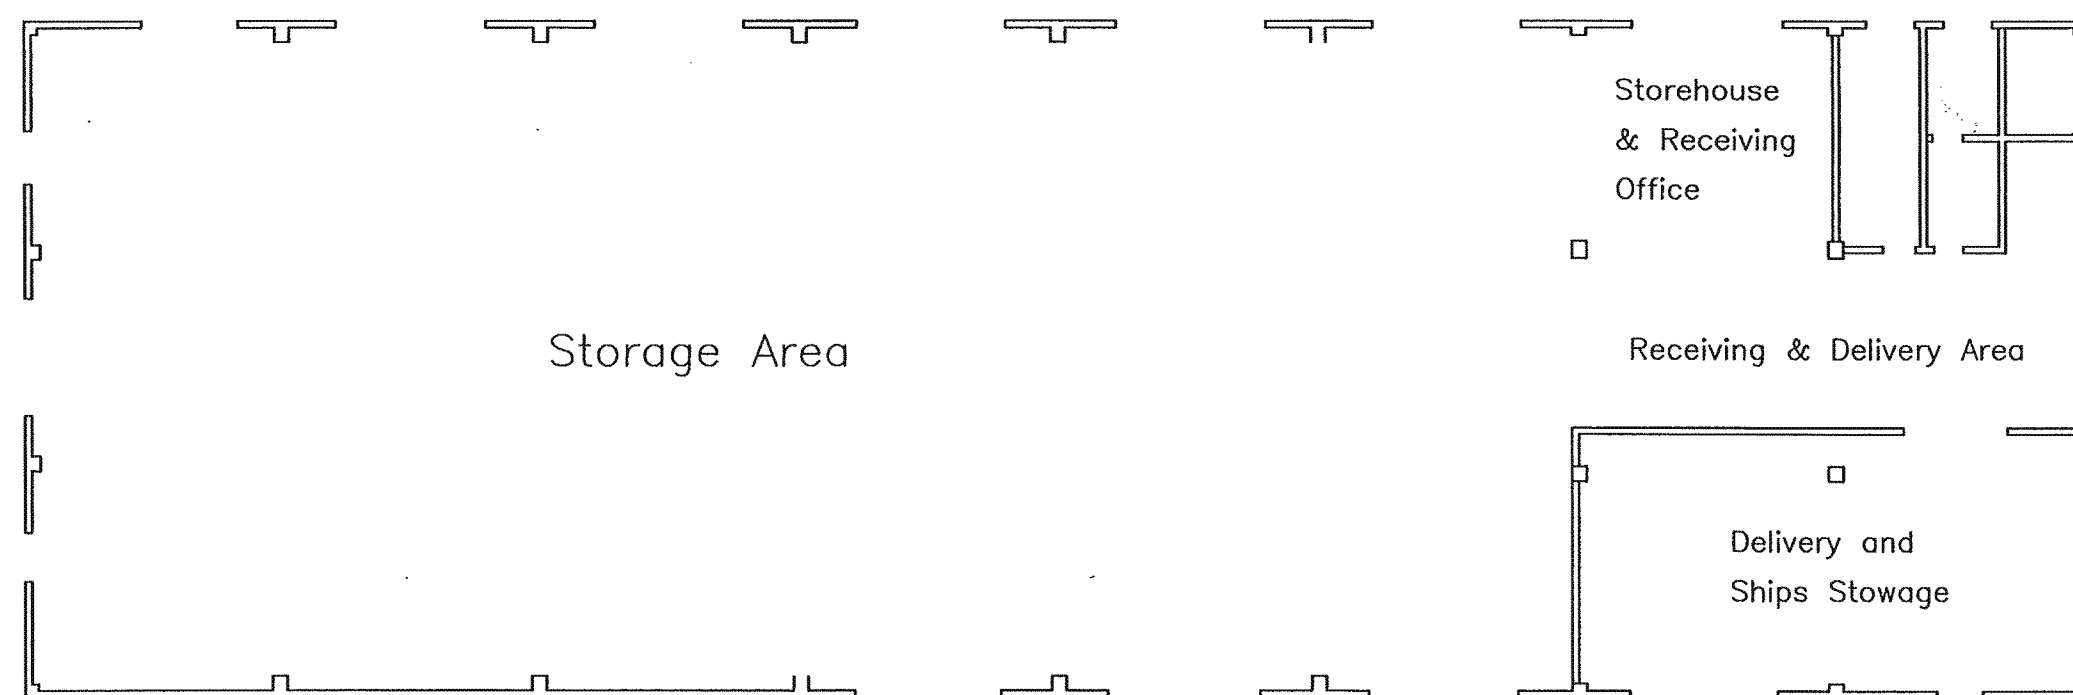
First Floor Plan

Floorplan recreated from background image Map ID 167.

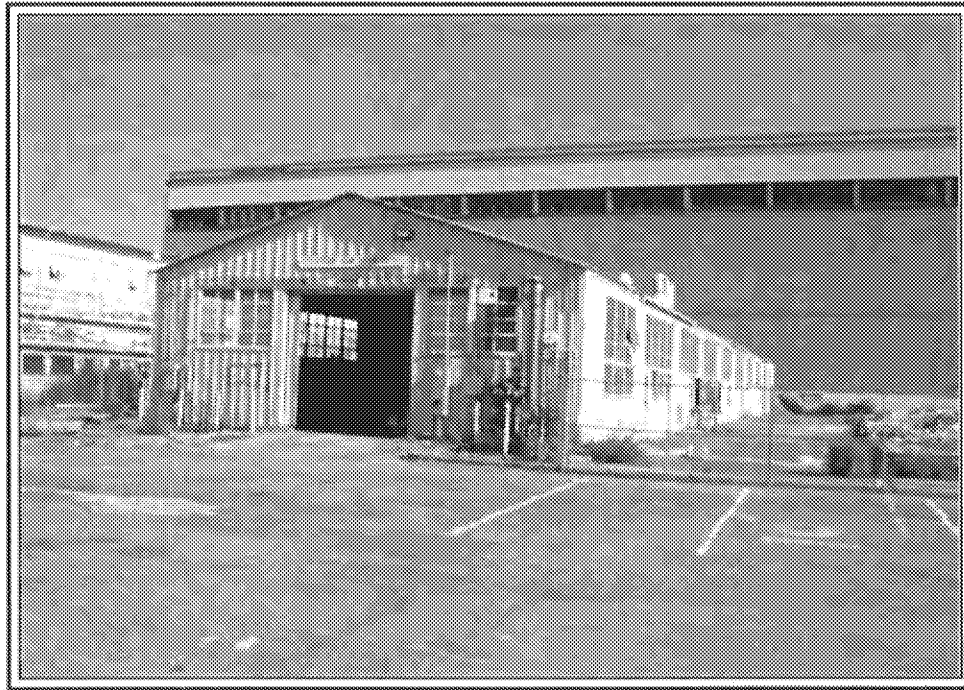
Site Description: Building 271 is a single-width, metal-sided shop building that was built in 1947 and manufactured by the Butler Company or in the manner of Butler Company buildings. This prefabricated, standard building was used on military bases due to limited budgets (HRA-1118, p 106). A building site plan is provided in Figure 8.3.3.8.

Recommended Actions: Review Final Status Survey Report.
